Use of a Porous Alumina Antibiotic-Loaded Ceramic to Treat Bone Defect and Bone Infection After Road Trauma

JAAOS Glob Res Rev 2022;6: e21.00257

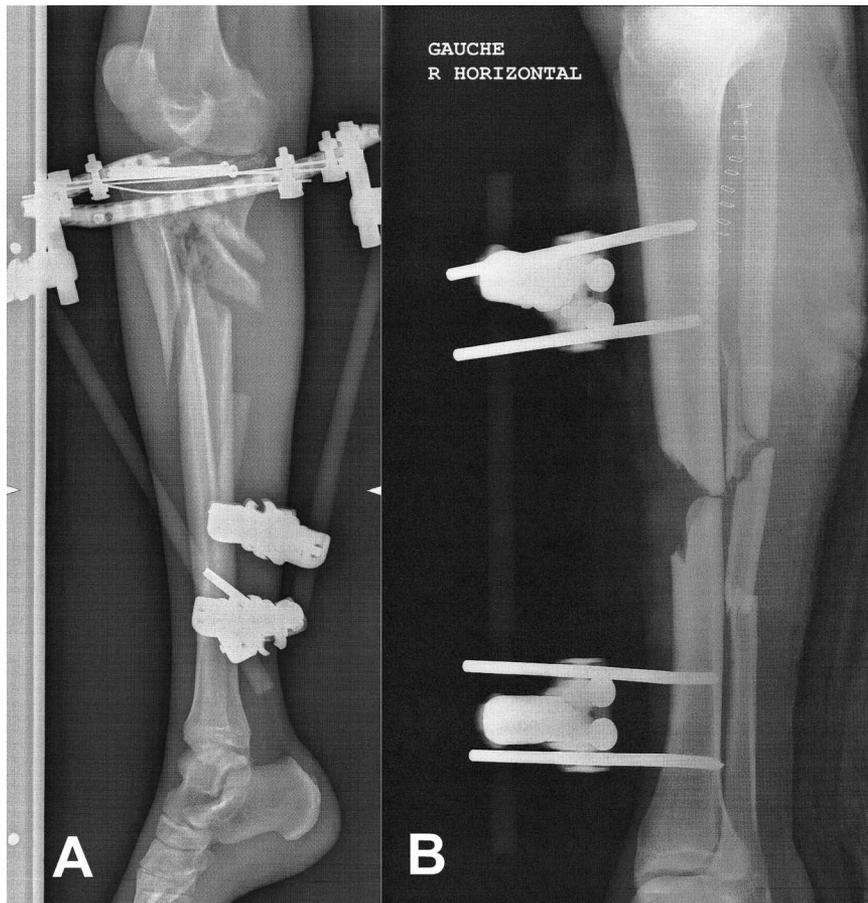
Figure 1

Radiograph after the first surgery for the management in emergency of the road accident: **(A)**, right side and **(B)** left side

A 70-year-old man presented open fractures and bone loss of both tibiae after a motorcycle accident. On the right side, there was a comminuted fracture at the proximal metaphyseal level (Figure 1, A). He developed a fistula and a *Stenotrophomonas maltophilia* infection. On the left side, there was a diaphyseal bone defect (Figure 1, B) with an *Enterobacter cloacae* infection. This followed initial débridements and the placement of bilateral external fixators and antibiotic-loaded cement to fill the defects. The option recommended by several surgeons, given the bone condition and patient medical history, was bilateral amputation. Comorbidities included diabetes, hypertension, and severe peripheral arterial disease with previous bypasses and stents and the need for a left femoral-popliteal bypass after the initial trauma. Moreover, after the trauma, there was a need for a distal left femoral-popliteal vein bypass. Because we did not have a conventional option to use to allow consolidation of these fractures in the context of infection and we had heard of a loaded ceramic used in bone infections, we turned to this option.

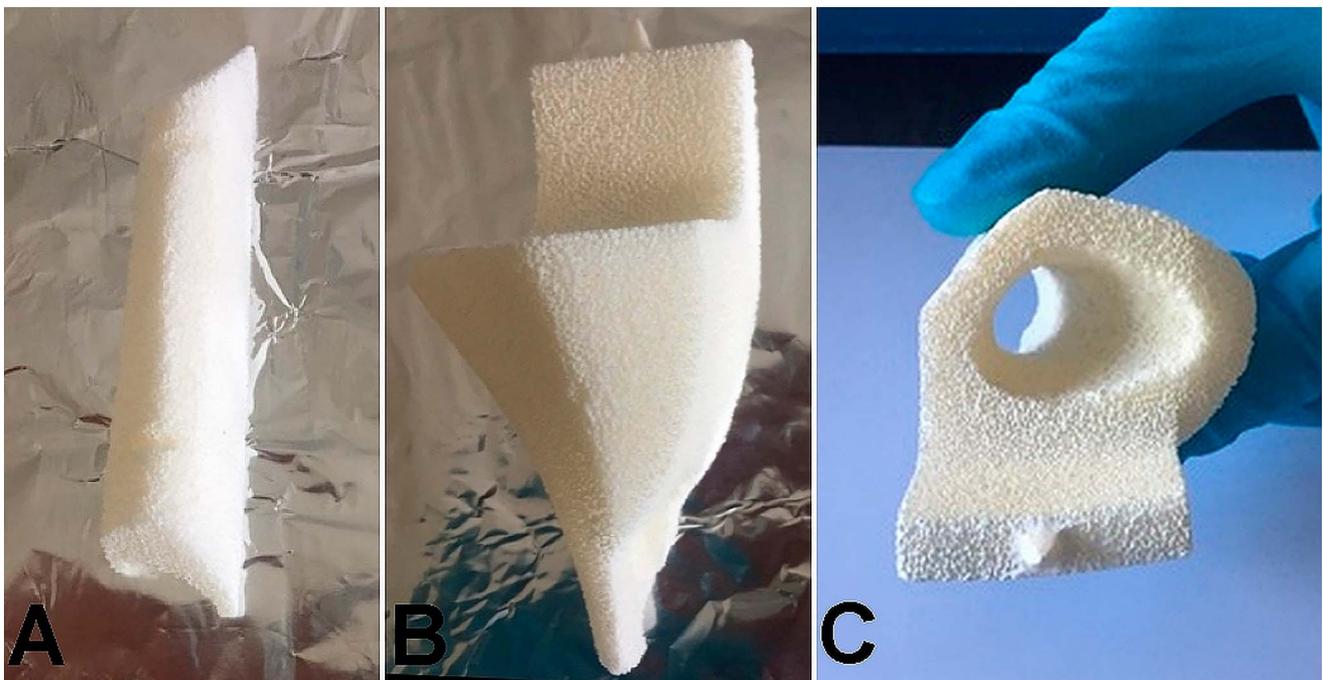
Figure 2

Ceramic parts: **(A)** the one for the left side, lateral view. The one for the right side **(B)** lateral view and **(C)** upper view

Shapes of the ceramic (Figure 2, A–C) were tailor made according to the defects. The design of the shapes was aided by 3D modeling and plastic 3D printing of the bones to better visualize the defects and how to replace them (Addidream, Limoges, France) (Figure 3). Loaded antibiotics were 250 mg of vancomycin and 160 mg of gentamicin (in each ceramic) to cover the known bacteria but also some others such as *Pseudomonas*

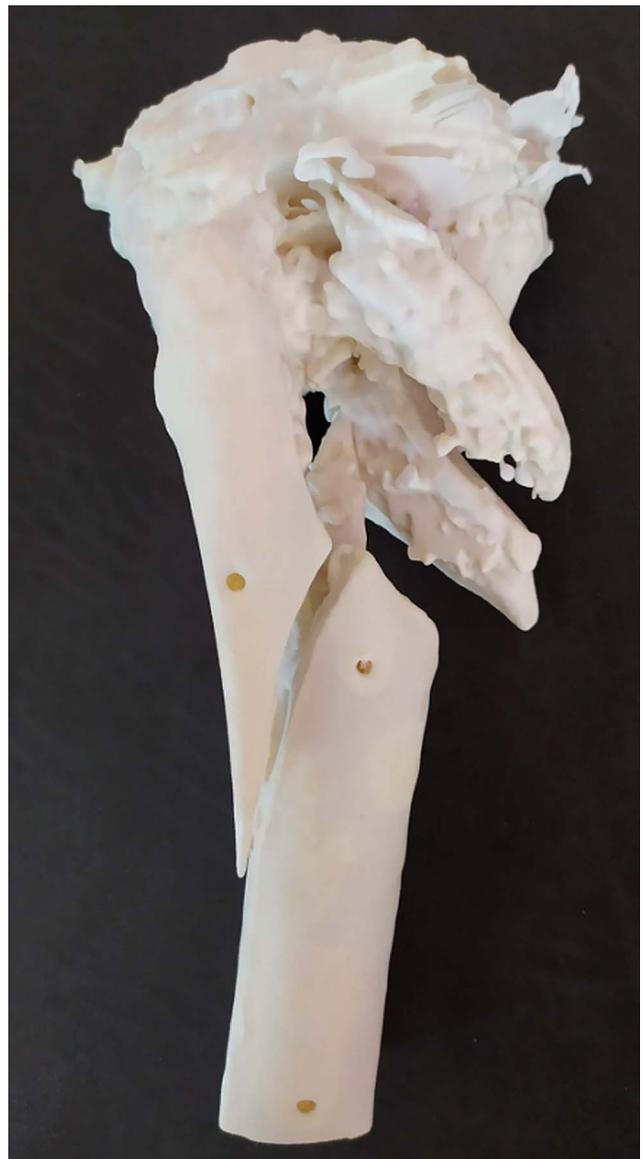
Figure 3

3D plastic printed part made according to the scanner of the right tibia

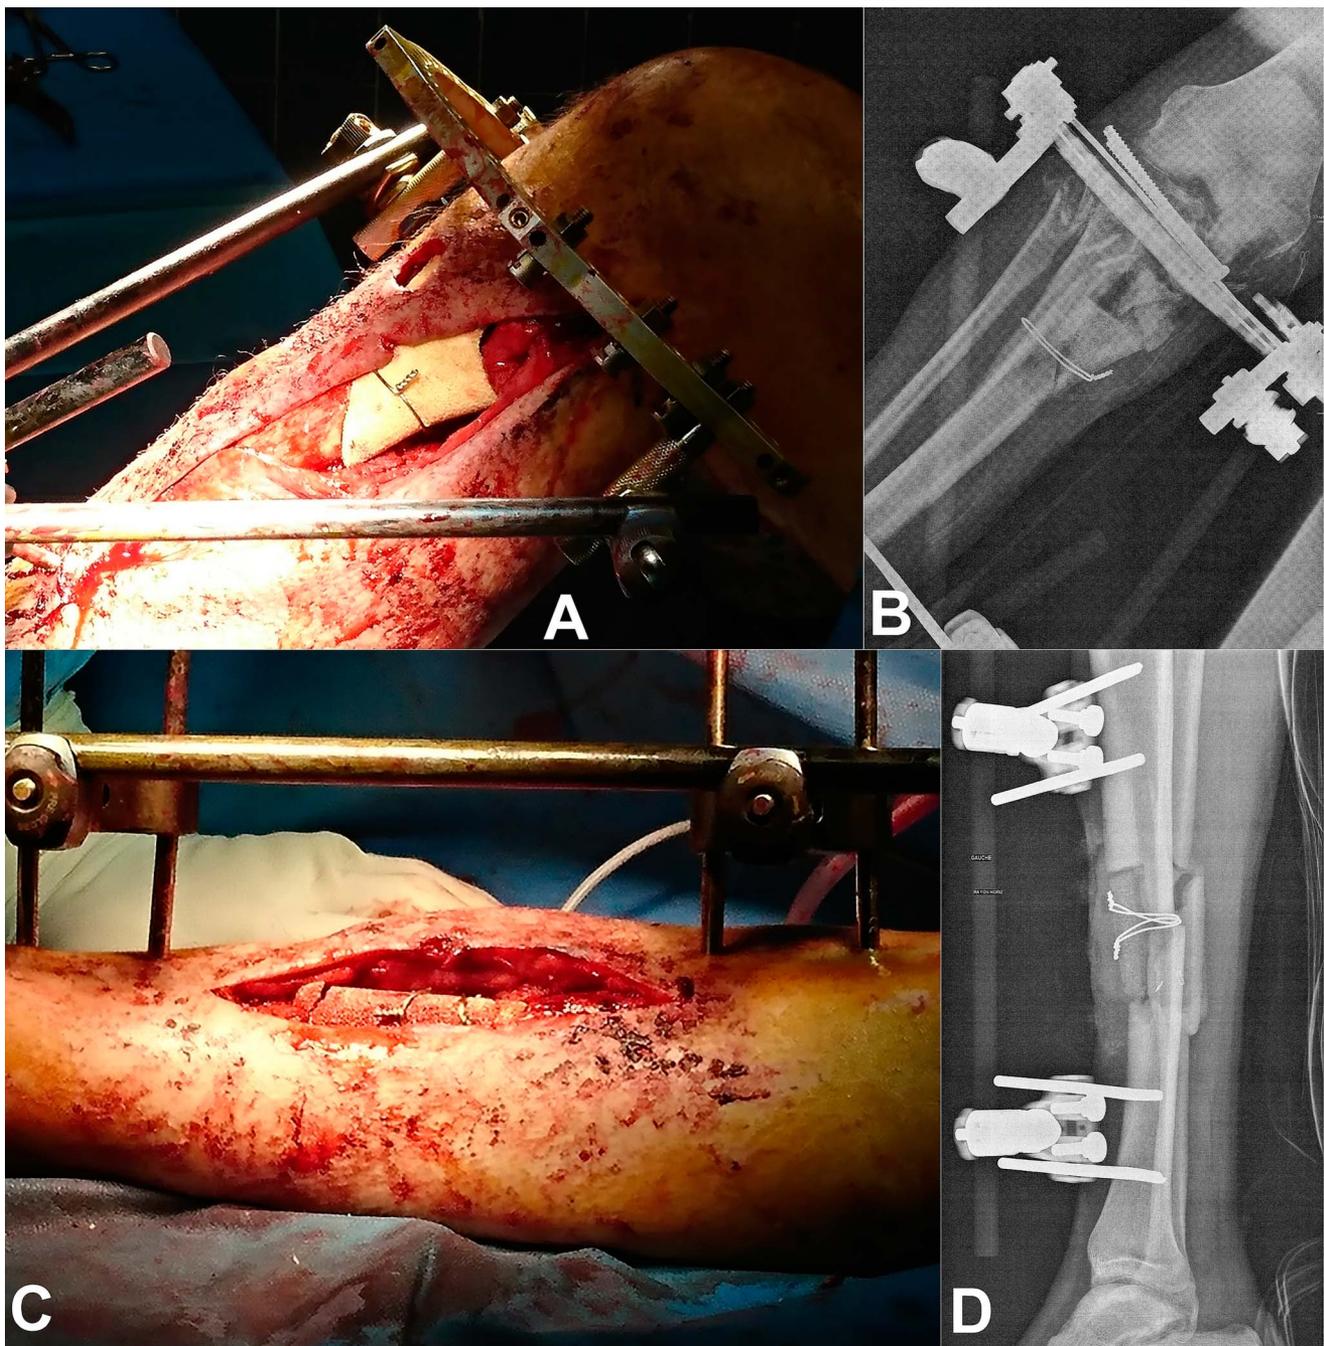
Figure 4

Implantation of the ceramic: **A**, Intraoperative view of the right tibia, **(B)** postoperative radiograph of the right tibia, **(C)** intraoperative view of the left tibia, and **(D)** postoperative radiograph of the left tibia

For ceramic implantation, cutting guides helped the placement of the devices. This surgery was performed 4 months after the accident. After débridement and cleaning, ceramics were placed and secured with metal

straps (Figure 4, A–D). External fixators were left in place during healing for 3 months and then removed. A centromedullary nail was placed in the left tibia to reduce an axial shift because of the use of a monoplane external fixator instead of the previous multiplane one. All bacteriological samples performed during this surgery were sterile. Six months after the accident and

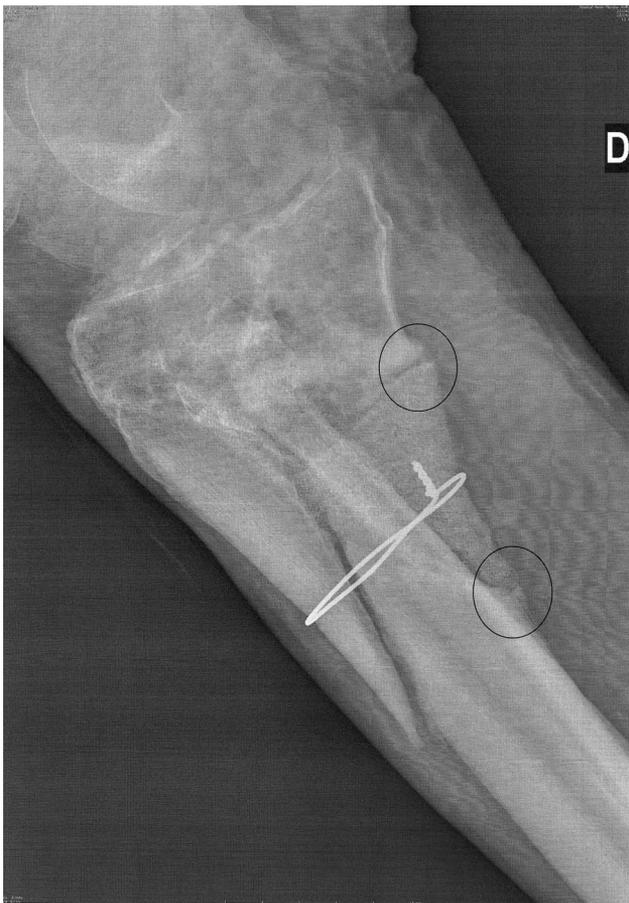
Figure 5

Radiograph of the right tibia performed 7 months after ceramic implantation and 4 months after external fixator removal showing a growth of bone in contact with the ceramic (circles)

3 months after the use of this ceramic, the patient was allowed to weightbear as tolerated. The ceramic pieces were left in place. Radiograph 6 months after implantation revealed signs of bone growth in contact with the ceramic (Figure 5). After a follow-up of more than 18 months, there is no relapse of infection or fistulae. Radiograph at this time displayed images of ceramic included in bone with bone beginning to encompass the ceramic (Figure 6).

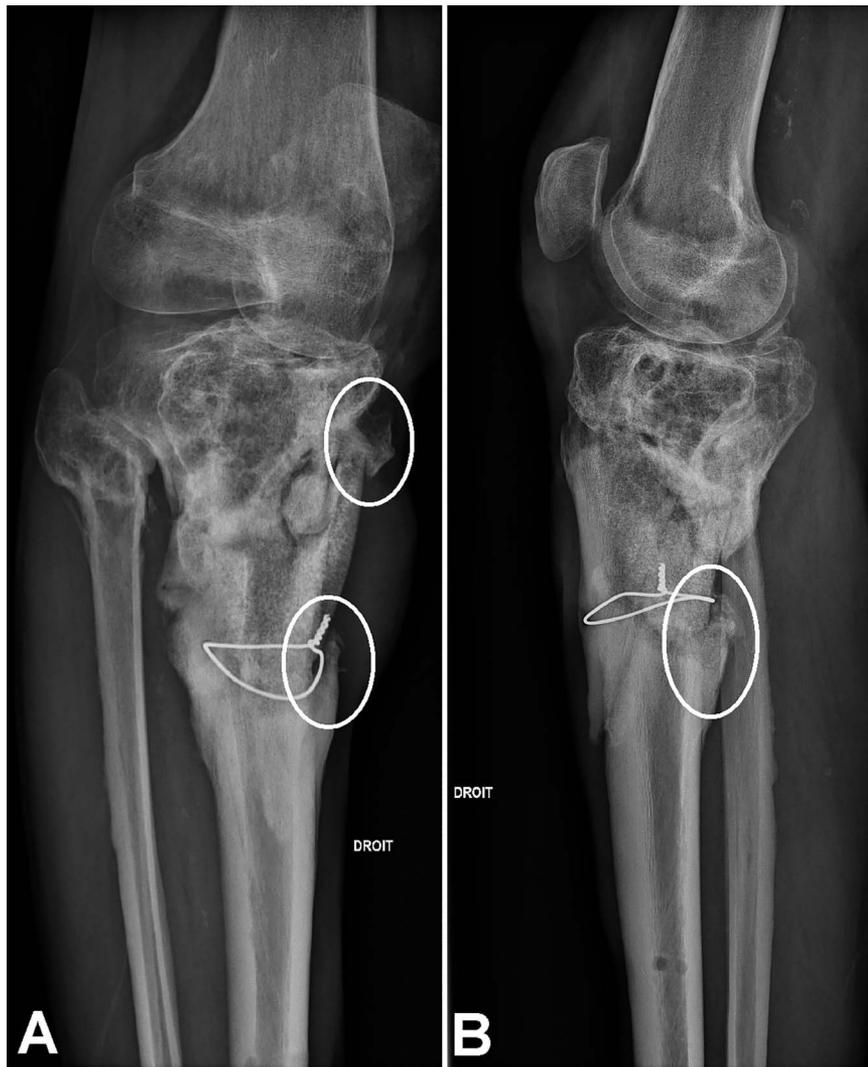
Figure 6

A, Front and **(B)** side radiograph of the right tibia performed 18 months after ceramic implantation. White circles indicate bone growth.
